VIP Drum Reconditioners, Seven Hills
Emission Testing Report
Report Number R012983

Client Name: VIP Drum Reconditioners
Report Number: R012983
Date of Issue: 26 July 2022
Attention: Grant McNally
Address: 30-32 Powers Rd
Seven Hills NSW 2147
Testing Laboratory: Ektimo Pty Ltd, ABN 86 600 381 413

Ektimo was engaged by VIP Drum Reconditioners to perform emission testing at their Seven Hills plant. Testing was carried out in accordance with Environmental Protection Licence 124.

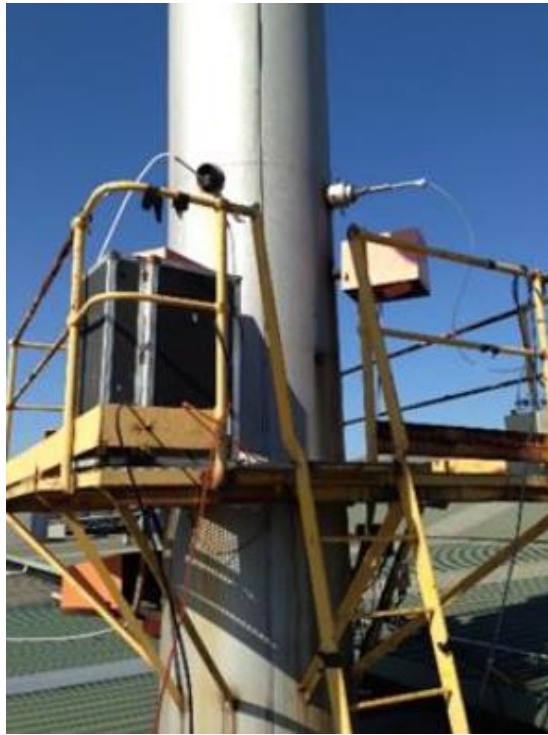
EPA 1 – Afterburner Discharge Stack

Sampling plane dimensions	1035 mm
Sampling plane area	0.841 m ²
Sampling port size, number & depth	4" BSP (x2), 80 mm
Access & height of ports	Step ladder 8 m
Duct orientation & shape	Vertical Circular
Downstream disturbance	Exit 7 D
Upstream disturbance	Change in diameter 3 D
No. traverses & points sampled	2 16
Sample plane conformance to AS4323.1 (2021)	Conforming but non-ideal

The sampling plane is too near to the upstream disturbance but is greater than or equal to 2D

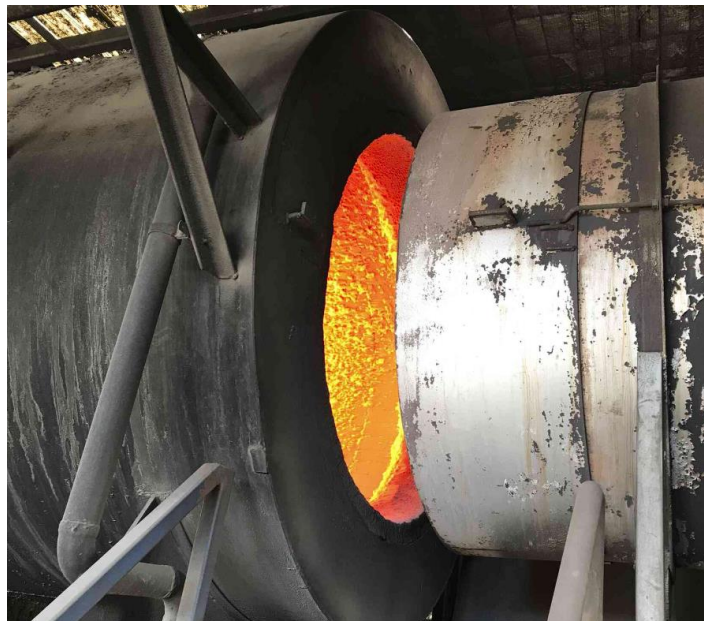
EPA 2 – Cooling Air Vent

The cooling air vent (EPA 2) consists of an open slot around the entire 4555mm circumference of the waste air duct stemming from the afterburner. The width of this slot is variable. Fresh ambient air is drawn through the slot under venturi. On the day of sampling the slot was open to a width of 220mm. Velocity measurements were taken with a pitot probe at three accessible locations around the circumference. All calculations assume that the cooling air vent flow into the afterburner waste air duct is consistent and uniform across the entire width and circumference of the slot.

Sampling plane dimensions	4555 x 220 mm
Sampling plane area	1 m ²
Sampling port size, number & depth	NA, 0 mm
Access & height of ports	Stairs 3 m
Duct orientation & shape	Horizontal Rectangular
Downstream disturbance	Change in diameter 0 D
Upstream disturbance	Change in diameter 0 D
No. traverses & points sampled	4 4
Sample plane conformance to AS4323.1 (2021)	Non-conforming

Slot width is 220mm this year
 The number of points sampled is less than the requirement
 The discharge is assumed to be composed of dry air and moisture

The downstream disturbance is <1D from the sampling plane
 The upstream disturbance is <2D from the sampling plane
